EM 1110-2-2002

30 June 1995

Engineering and Design
EVALUATION AND REPAIR OF CONCRETE STRUCTURES

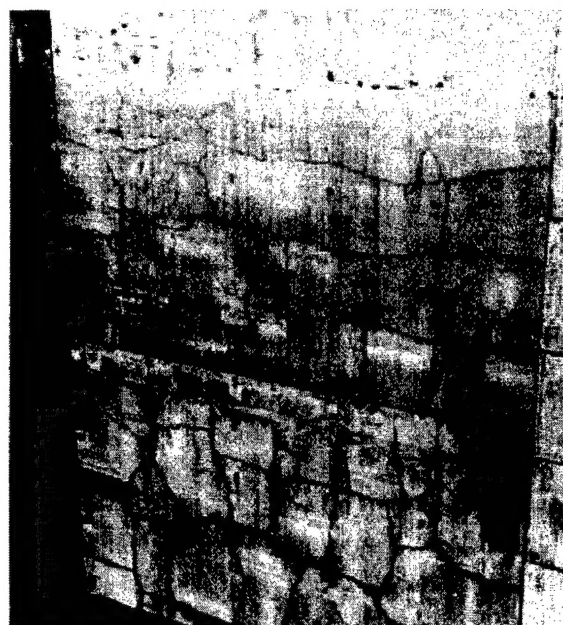
Figure 2-5. Pattern cracking caused by restrained volume changes

(a) Surface appearance of cracks. The surface appearance of cracks can give the first indication of the cause of cracking. Pattern cracks (Figures 2-5 through 2-7) are rather short cracks, usually uniformly distributed and interconnected, that run in all directions. Pattern cracking indicates restraint of contraction of the surface layer by the backing or inner concrete or possibly an

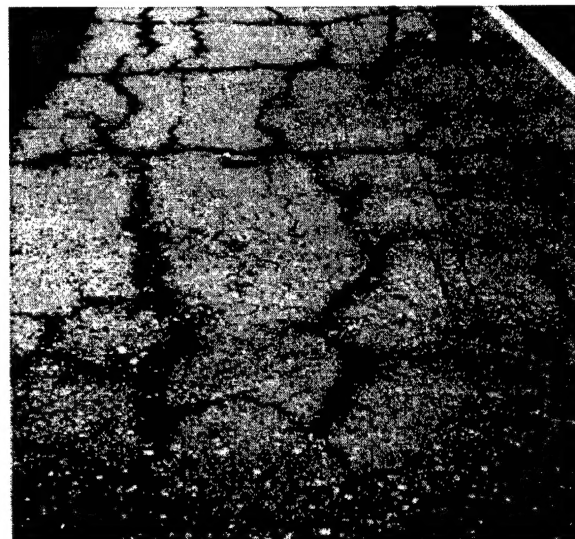
Figure 2-6. Pattern cracking resulting from alkali-silica reaction

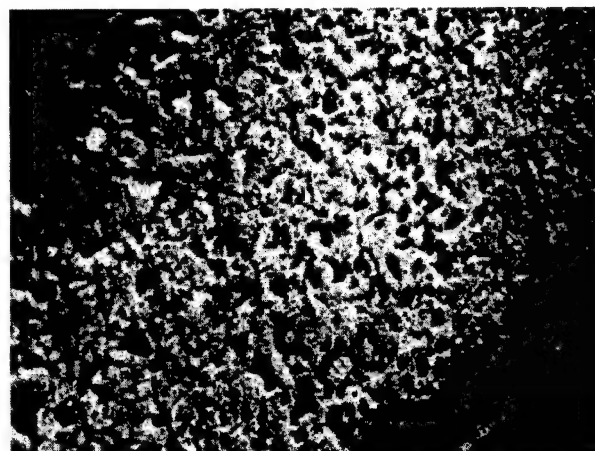
Figure 2-12. Disintegration of concrete caused by exposure to aggressive water

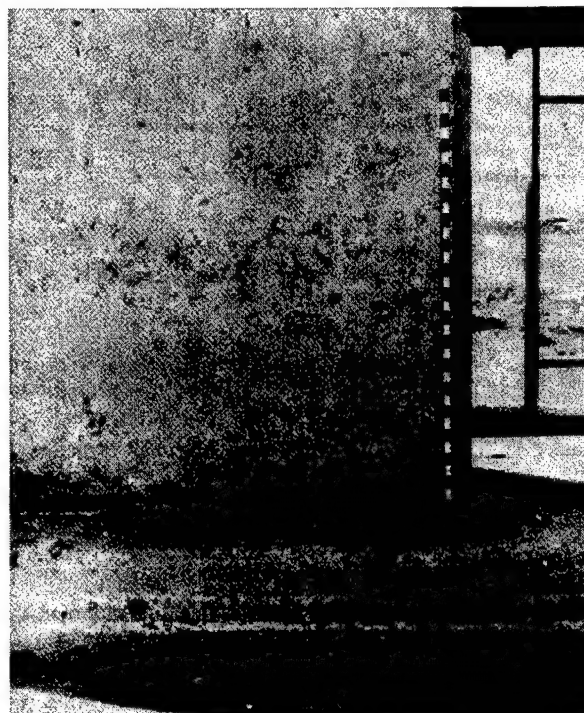
Figure 2-16. Light scaling

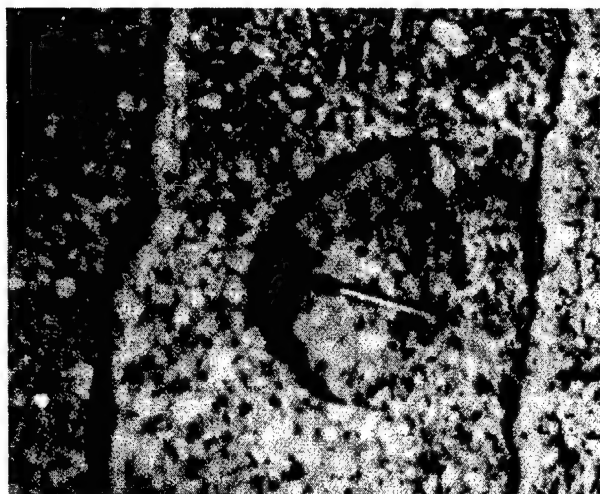
Figure 2-29. Small spall

(a) Small spall. Not greater than 20 mm (0.8 in.) in depth nor greater than 150 mm (6 in.) in any dimension (Figure 2-29).

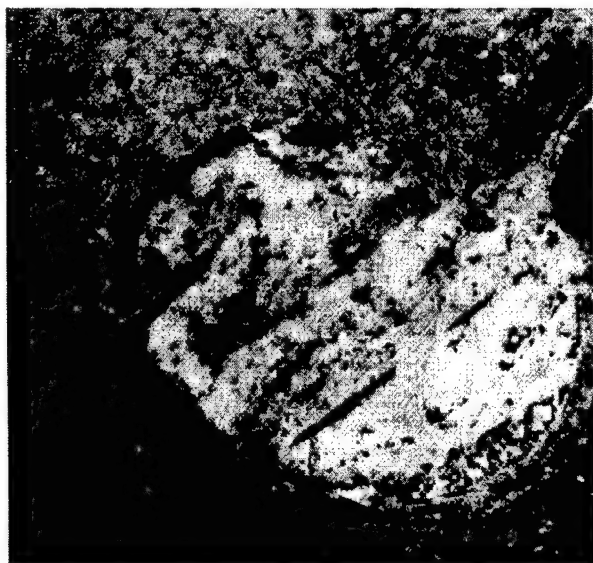
Figure 2-30. Large spall

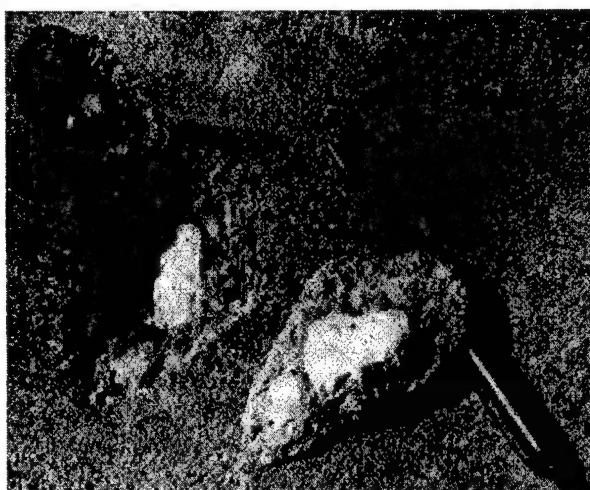
Figure 2-31. Popout

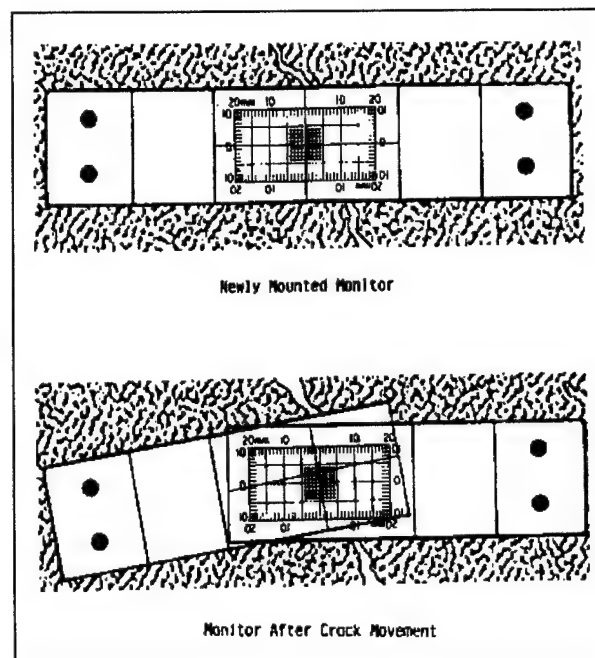
Figure 2-33. Crack monitor

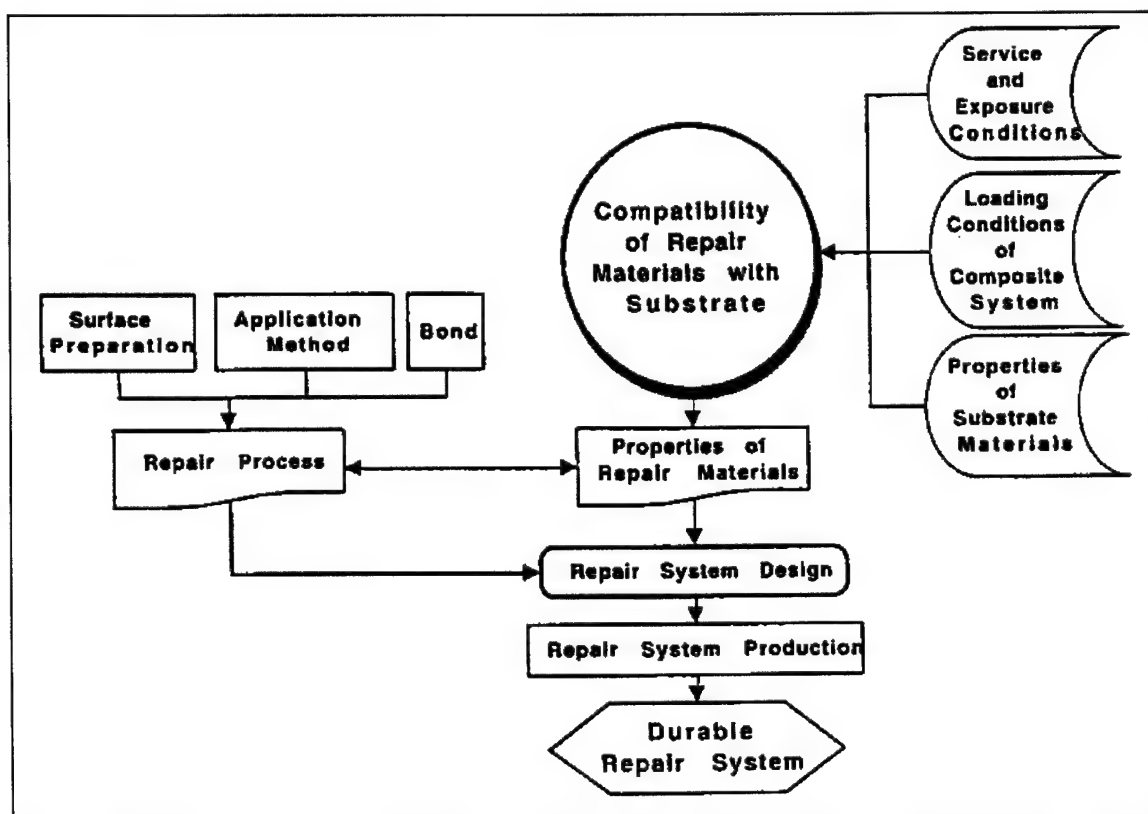
Figure 4-1. Factors affecting the durability of concrete repair systems (Emmons and Vaysburd 1995)

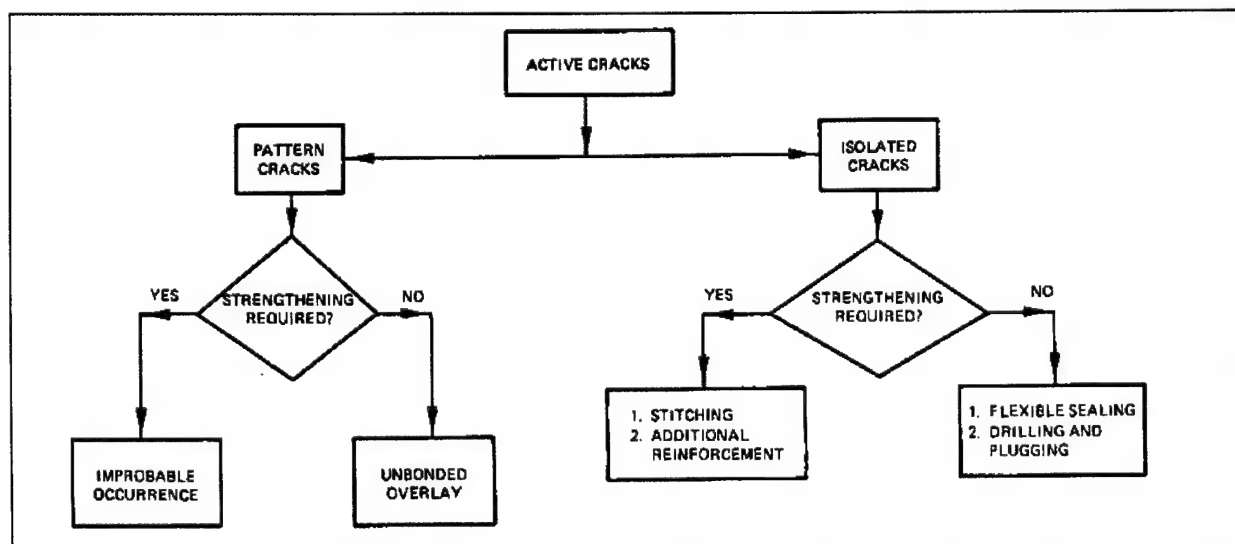
Figure 4-3. Selection of repair method for active cracks (after Johnson 1965)

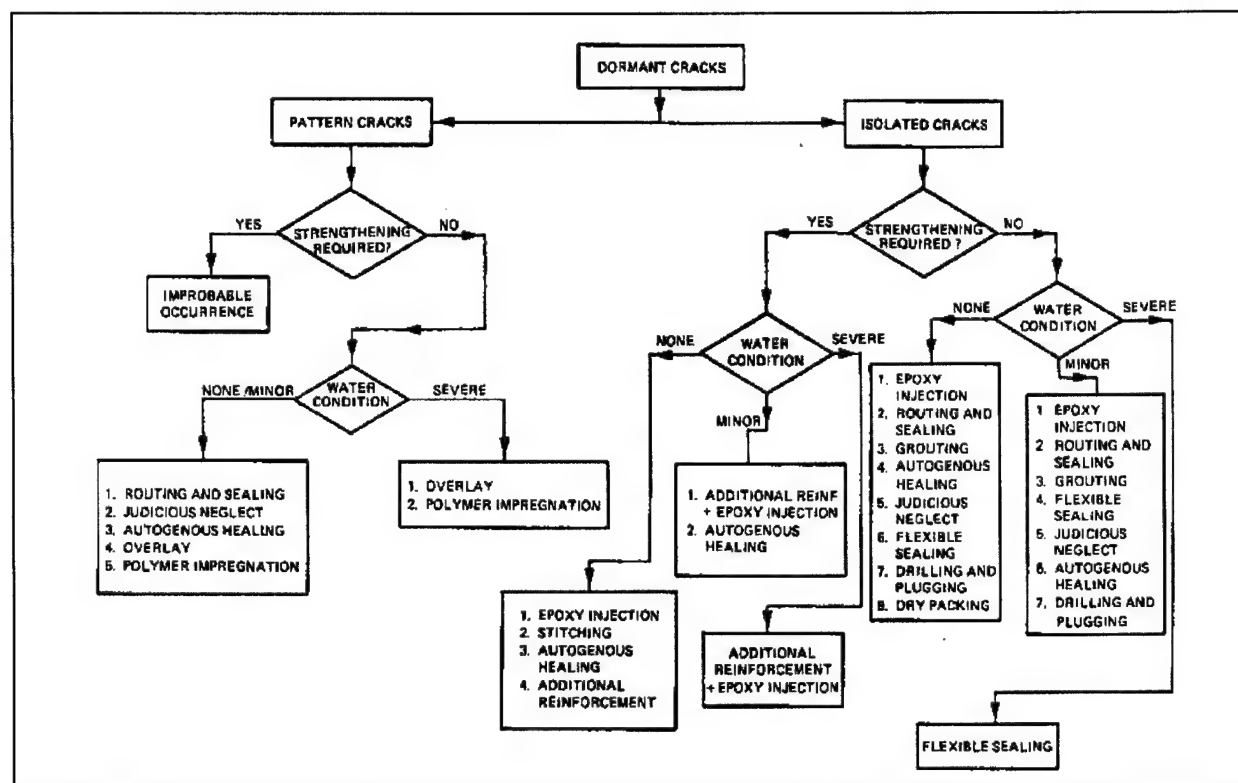
Figure 4-4. Selection of repair method for dormant cracks (after Johnson 1965)

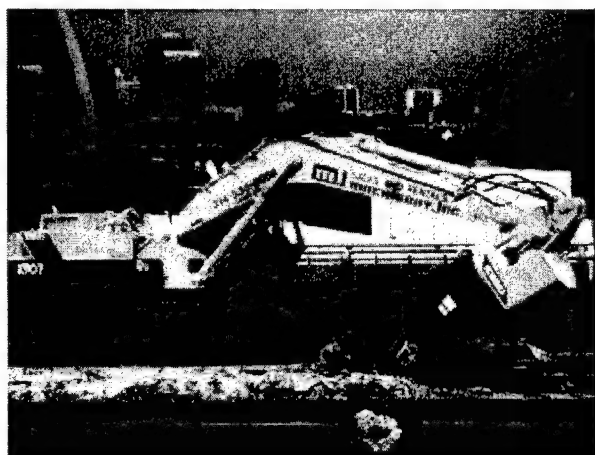
Figure 5-2. Boom-mounted concrete crusher

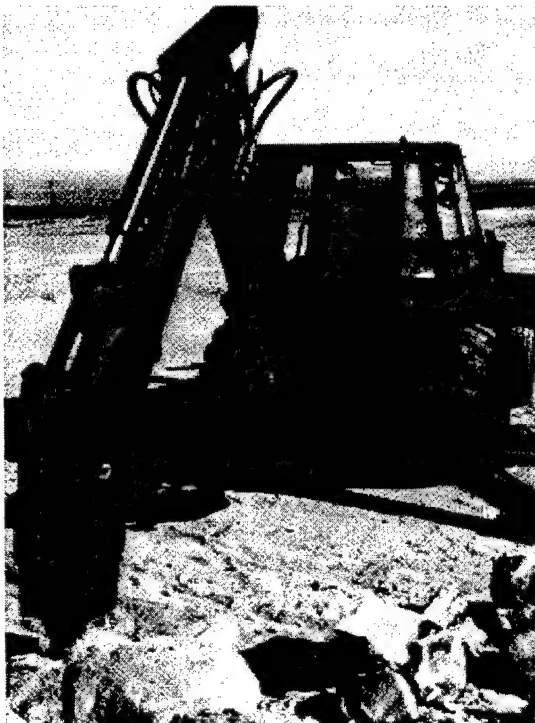
Figure 5-7. Boom-mounted breaker

(1) Boom-mounted breakers. Boom-mounted impact breakers are applicable for both full- and partial-depth removals where production rates required are greater than can be economically achieved by the use of hand-held breakers. The boom-mounted breakers are somewhat similar to the hand-held breakers except that they are considerably more massive. The tool is normally attached to the hydraulically operated arm of a backhoe or excavator (Figure 5-7) and can be operated by compressed air or hydraulic pressure. The reach of the hydraulic arm enables the tool to be used on walls at a considerable distance above or below the level of the machine. Boom-mounted breakers are a highly productive means of removing concrete. However, the blow energy delivered to the concrete should be limited to protect the structure being repaired and surrounding structures from damage resulting from the high cyclic energy generated. Saw cuts

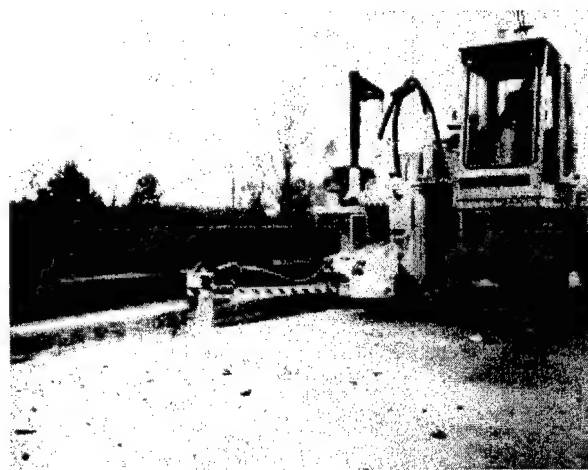
Figure 5-8. Spring-action hammer (mechanical sledgehammer)

(2) Spring-action hammers. Spring-action hammers (sometimes referred to as mechanical sledgehammers) are boom-mounted tools that are applicable for breaking concrete pavements, decks, walls, and other thin members where production rates required are greater than can be economically achieved with the use of hand-held breakers. Hammers are more applicable for total demolition of a concrete member than for removal to rehabilitate or repair. The arm of the hammer is hydraulically powered, and the impact head is spring powered. The spring is compressed by the downward movement of the arm of the backhoe or excavator and its energy released just prior to impact. There are truck units available that make it easier to move between projects. The operation of the hammer and advancement of the truck during removal are controlled from a cab at the rear of truck (Figure 5-8). The blow energy delivered to the concrete should be limited to protect the structure being repaired and surrounding structures from damage caused by the high cyclic energy generated. Saw cuts should be employed at removal boundaries to reduce the occurrence of feathered edges. The concrete that remains may be damaged (microcracking) along with the exposed reinforcing steel.

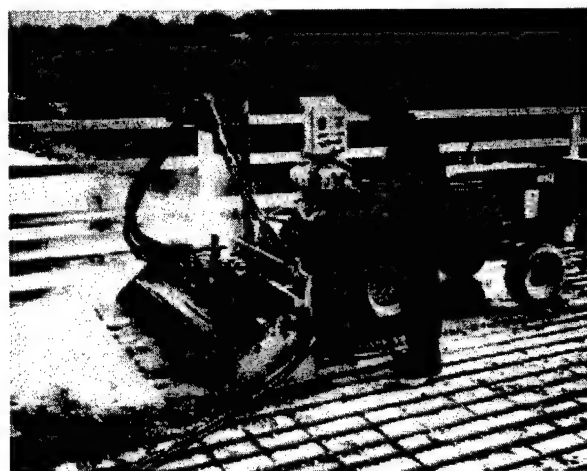
Figure 5-10. Hydromilling (water-jet blasting)

(1) Hydromilling. Hydromilling (also known as hydrodemolition and water-jet blasting) is applicable for removal of deteriorated concrete from surfaces of decks (Figure 5-10) and walls where removal depth is 150 mm (6 in.) or less. This method does not damage the concrete that remains and leaves the steel reinforcing undamaged for reuse in the replacement concrete. Its major limitations are that the method is costly, productivity is significantly reduced when sound concrete is being removed, and the removal profile varies with changes in depth of deterioration. Holes through members (blowouts) are a common occurrence when removal is near full depth of a member. This method requires a large source of potable water (the water demand for some units exceeds 4,000 L/hr (1,000 gal/hr)). An environmental impact statement is required if waste water is to enter a waterway. Personnel must wear hearing protection because of

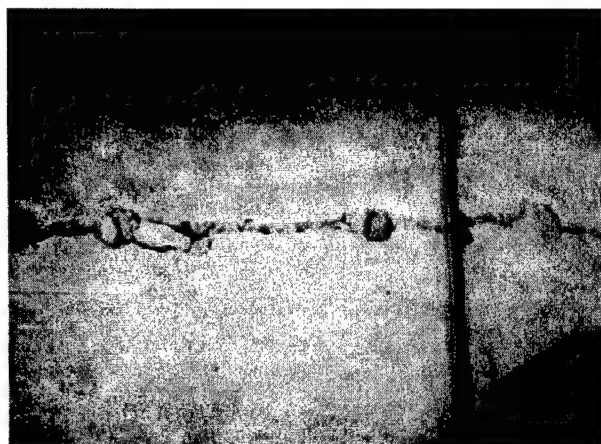
Figure 5-12. Presplitting using chemical-expansive agent

(1) Chemical presplitting, expansive agents. The presplitting method that uses chemical-expansive agents (Figure 5-12) is applicable for removal from slabs, walls, and other concrete members where depth of boreholes is 10 times the borehole diameter or greater. It is especially applicable for situations requiring the development of vertical presplitting planes of significant depth. The main disadvantages of employing expansive agents are cost and application-temperature limitations. Personnel must be restricted from the presplitting area during early hours of product hydration as the material has the potential to blow out of boreholes and cause injury. Expansive products that are prills or become slurries when water is added are best used in gravity filled, vertical or near-vertical holes. Some products form a clay-type material when mixed with water that allows the material to be packed into

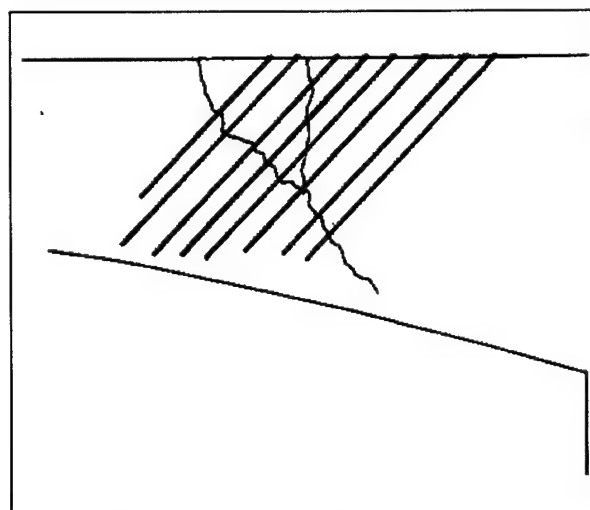
Figure 6-1. Crack repair using conventional reinforcement with drillholes 90 deg to the crack plane

(a) This technique consists of sealing the crack, drilling holes 19 mm (3/4 in.) in diam at 90 deg to the crack plane (Figure 6-1), cleaning the hole of dust, filling the hole and crack plane with an adhesive (typically epoxy) pumped under low pressure 344 to 552 KPa (50 to 80 psi), and placing a reinforcing bar into the drilled hole. Typically, No. 4 or 5 bars are used, extending at least 0.5 m (1.6 ft) on each side of the crack. The adhesive

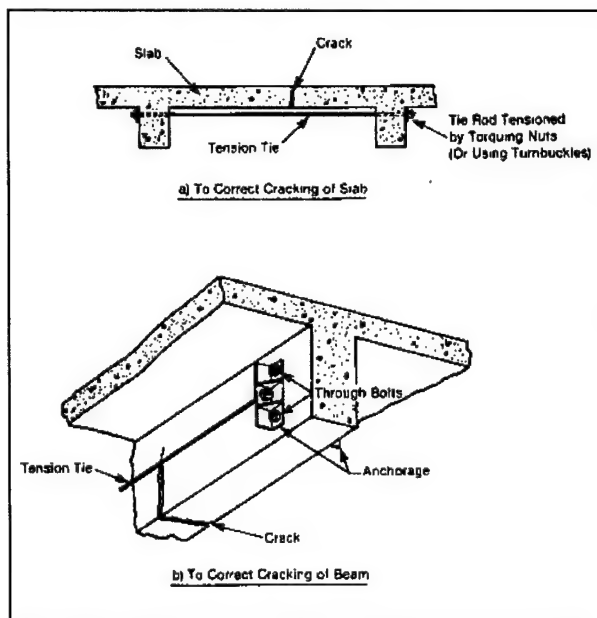
Figure 6-2. Crack repair with use of external prestressing strands or bars to apply a compressive force

(2) Prestressing steel. This technique uses prestressing strands or bars to apply a compressive force (Figure 6-2). Adequate anchorage must be provided for the prestressing steel, and care is needed so that the problem will not merely migrate to another part of the structure. The effects of the tensioning force (including eccentricity) on the stress within the structure should be carefully analyzed. For indeterminate structures posttensioned according to this procedure, the effects of secondary moments and induced reactions should be considered.

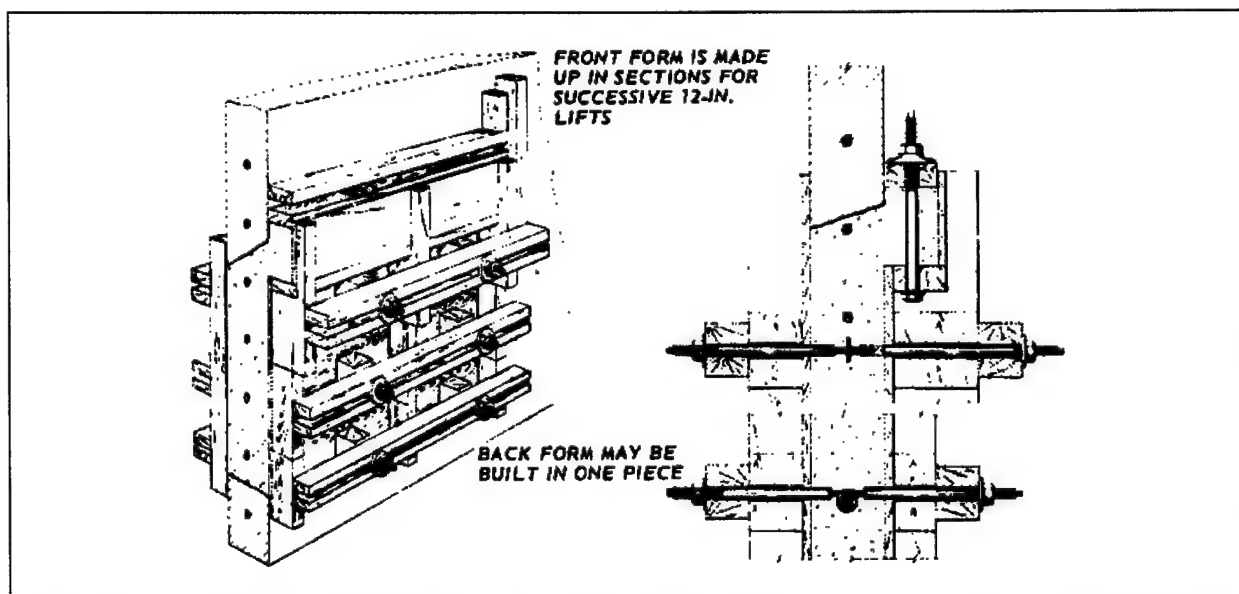
Figure 6-3. Detail of form for concrete replacement in walls after removal of all unsound concrete

(3) Forming will usually be required for massive repairs in vertical surfaces. The front form and the back form, where one is required, should be substantially constructed and mortartight. The back form may be assembled in one piece, but the front panel should be constructed as placing progresses so that the concrete can be conveniently placed in lifts. The contact surface should be dry at the time of patching. Small, thin repairs (less than 50 mm (2 in.) thick) should receive a bonding coat while thicker placements usually do not require a bonding coat (see paragraph 5-3a(2)(f)). The surface is first carefully coated with a thin layer of mortar, not exceeding 3 mm (1/8 in.) in thickness, containing sand passing the No. 16 sieve, and having the same w/c as the concrete to be used in the replacement. Hand-rubbing the mortar into the surface is effective. Epoxy resin

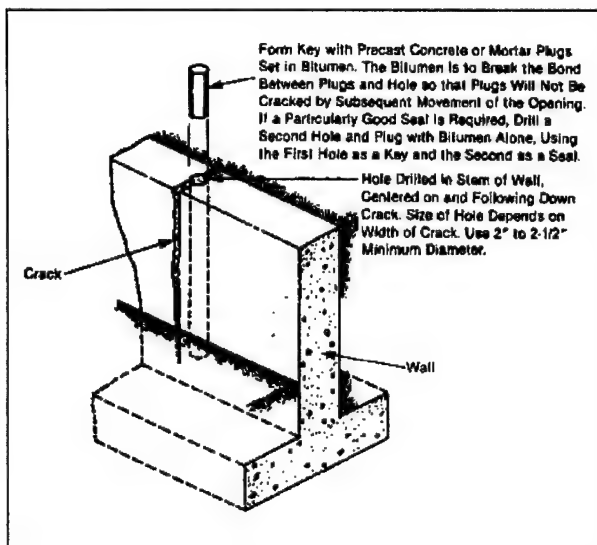
Figure 6-5. Repair of crack by drilling and plugging

a. *Description.* Drilling and plugging a crack consists of drilling down the length of the crack and grouting it to form a key (Figure 6-5).

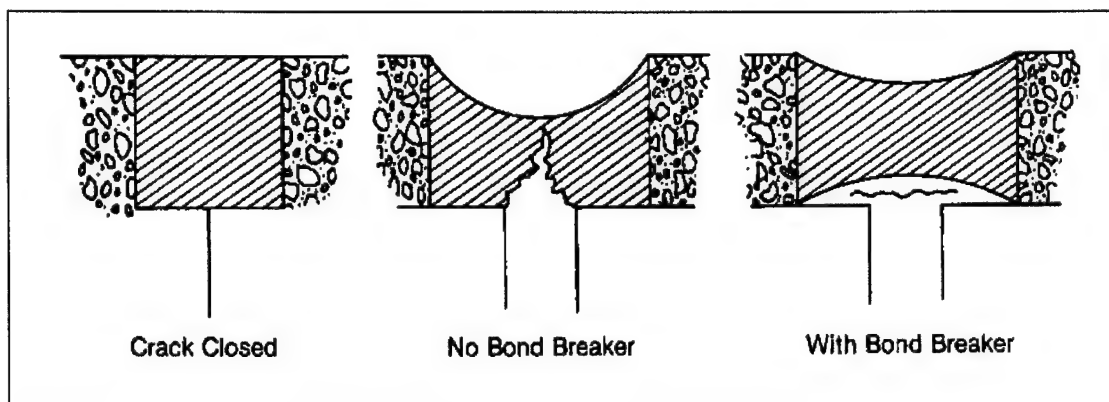
Figure 6-6. Effect of bond breaker involving a field-molded flexible sealant

(1) A bond breaker should be provided at the bottom of the slot to allow the sealant to change shape without a concentration of stress on the bottom (Figure 6-6). The bond breaker may be a polyethylene strip, pressure sensitive tape, or other material which will not bond to the sealant before or during cure.

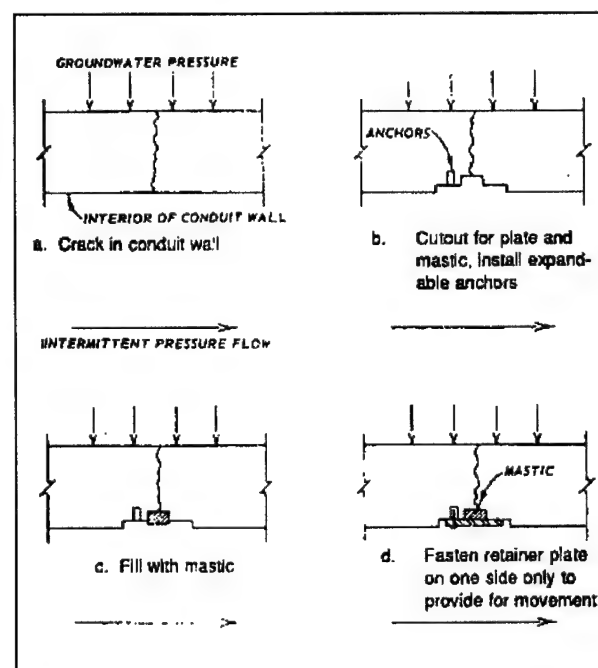
Figure 6-8. Repair of crack by use of a retainer plate to hold mastic in place against external pressure

necessary to cut the concrete surface adjacent to the crack and to place the retaining cap flush with the original flow lines (Figure 6-8).

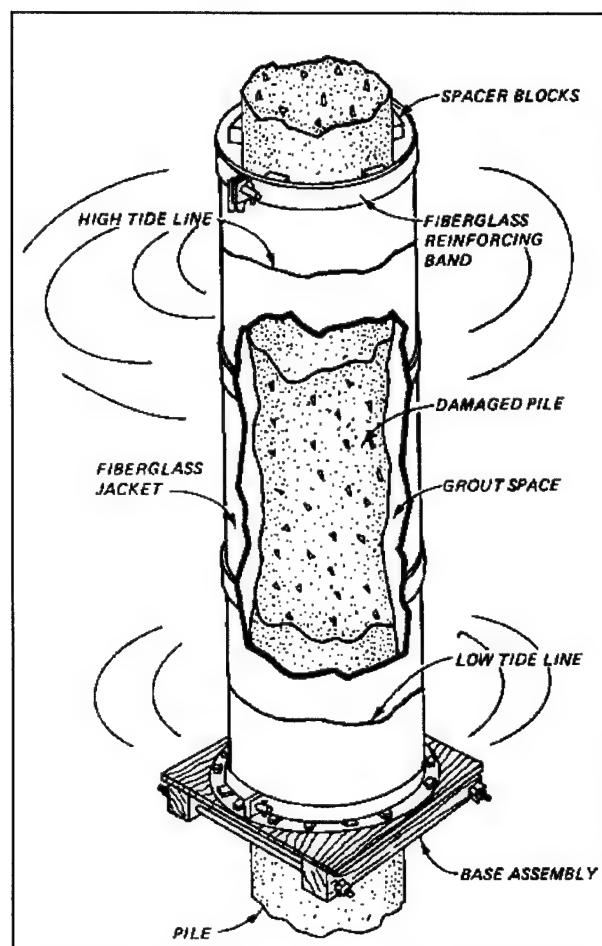
Figure 6-9. Typical preformed fiberglass jacket being used in repair of a concrete pile

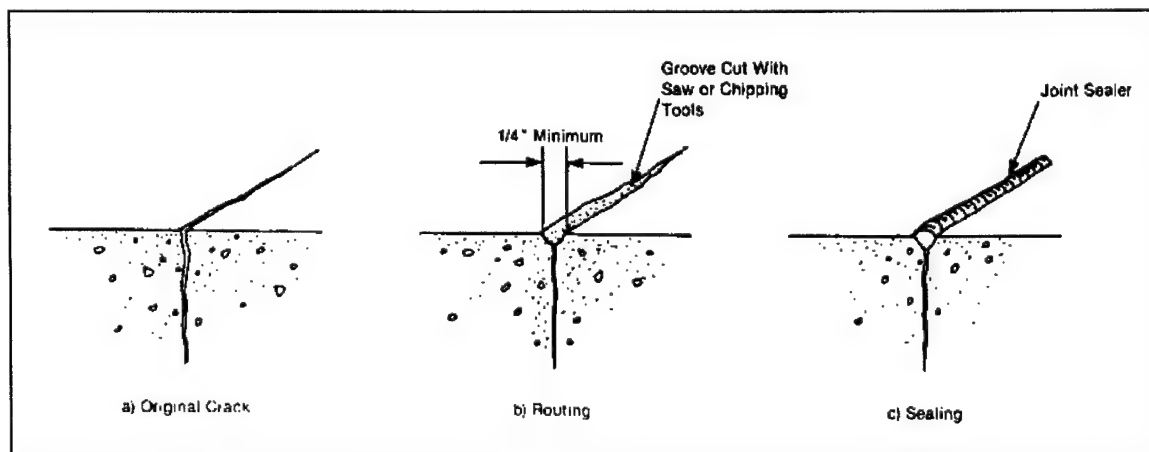
Figure 6-10. Repair of crack by routing and sealing

a. Description. This method involves enlarging the crack along its exposed face and filling and sealing it with a suitable material (Figure 6-10). The routing operation may be omitted but at some sacrifice in the permanence of the repair. This is the simplest and most common method for sealing dormant cracks.

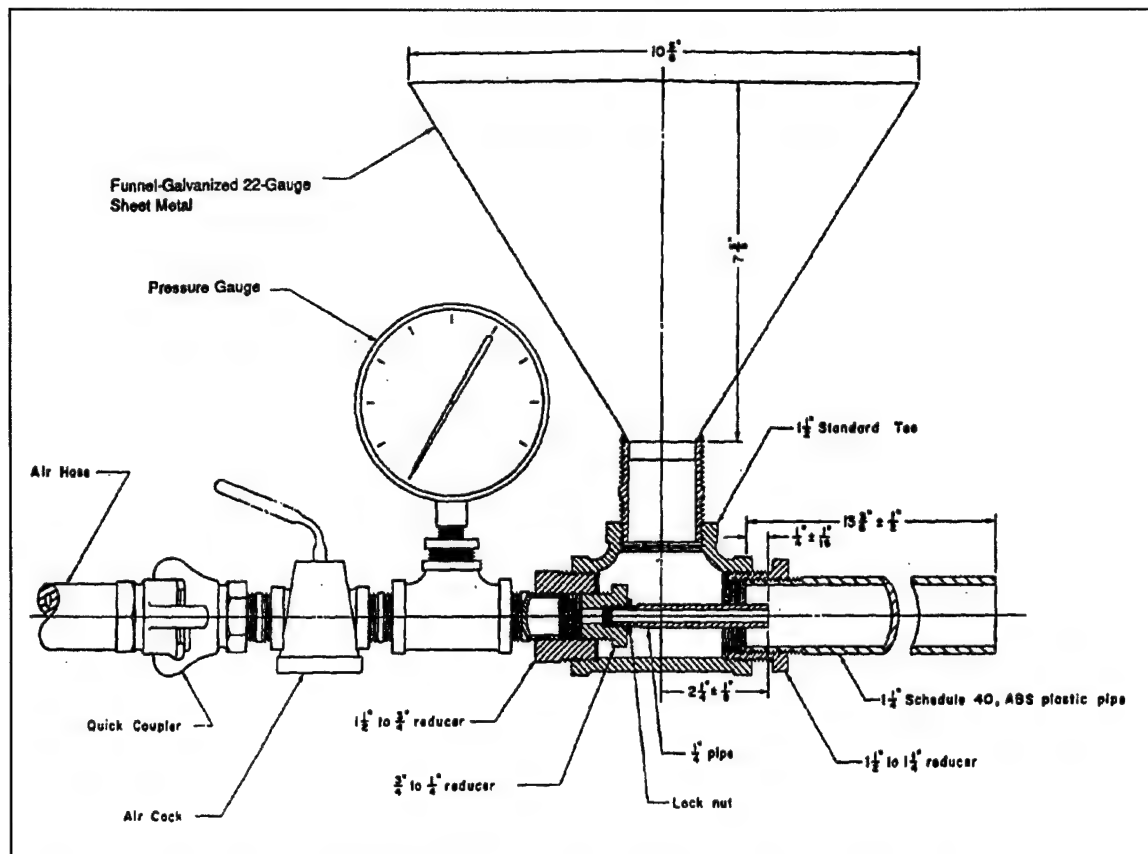
Figure 6-11. Mortar gun for concrete repair (U.S. Army Engineer Division, Missouri River 1974)

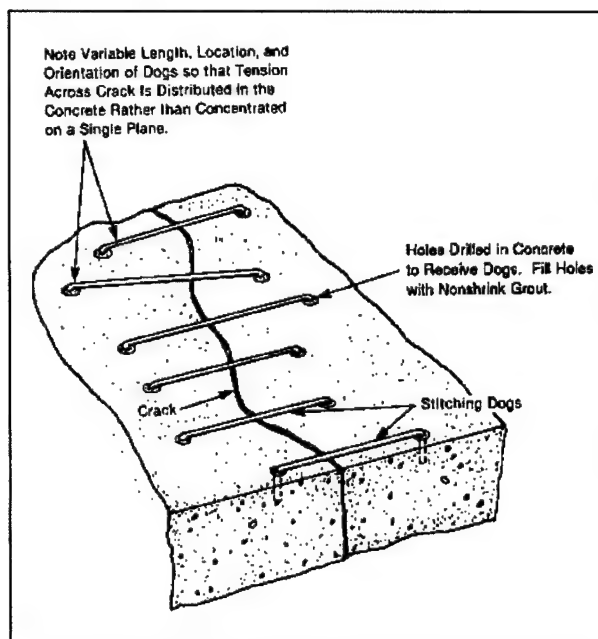
Figure 6-13. Repair of a crack by stitching

b. Applications and limitations. Stitching may be used when tensile strength must be reestablished across major cracks. Stitching a crack tends to stiffen the structure, and the stiffening may accentuate the overall structural restraint, causing the concrete to crack elsewhere. Therefore, it may be necessary to strengthen the adjacent

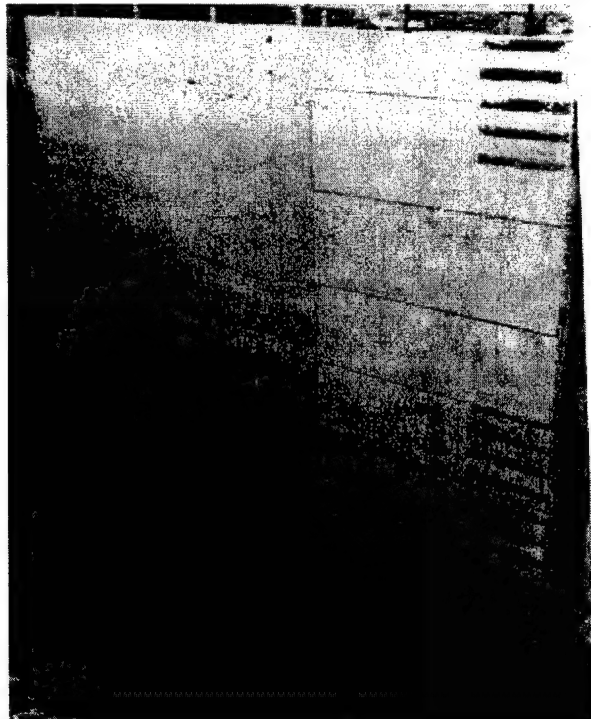
Figure 8-3. Concrete cracking in resurfaced monolith (left) compared to reconstructed monolith, Lock No. 1, Mississippi River

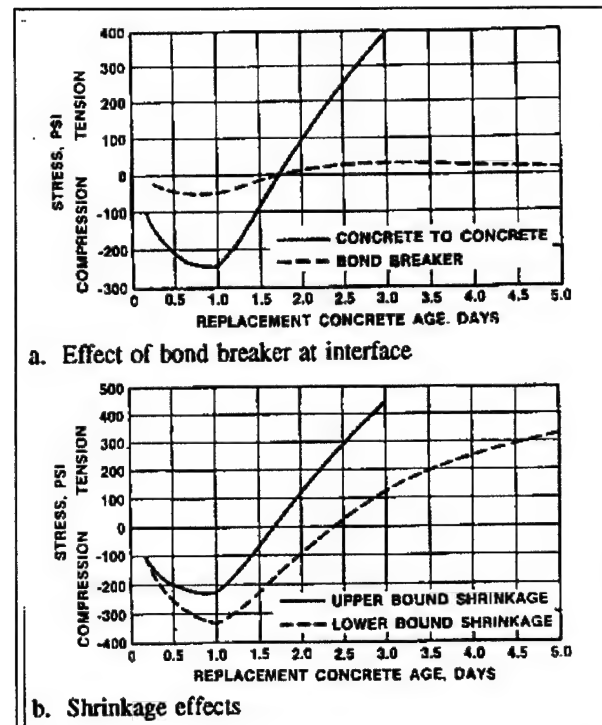
Figure 8-4. Results of a finite element analysis of a typical lock wall resurfacing

(a) A finite element analysis of a typical lock wall resurfacing (Norman, Campbell, and Garner 1988) also demonstrated the effect of restraint by the existing concrete. Under normal conditions of good bond between the two concretes, stress levels sufficient to cause cracking in the replacement concrete developed within about 3 days (Figure 8-4a). In comparison, a bond breaker at the interface resulted in almost no stress in the replacement concrete. The analysis also indicated that shrinkage was a significant factor (Figure 8-4b). Even the lower bound shrinkage resulted in tensile stresses in excess of 2.1 MPa (300 psi).

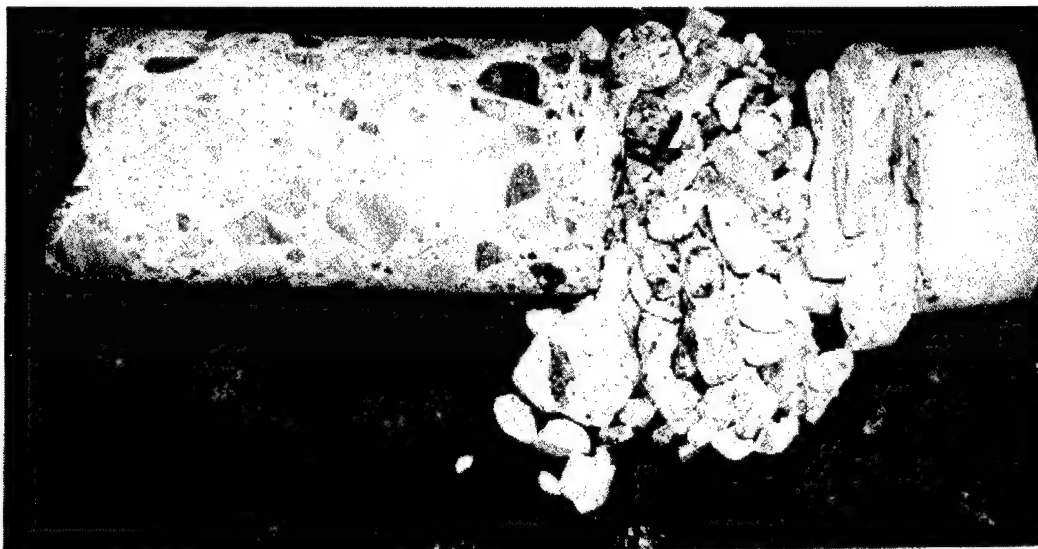
a. Concrete deterioration immediately behind shotcrete overlay

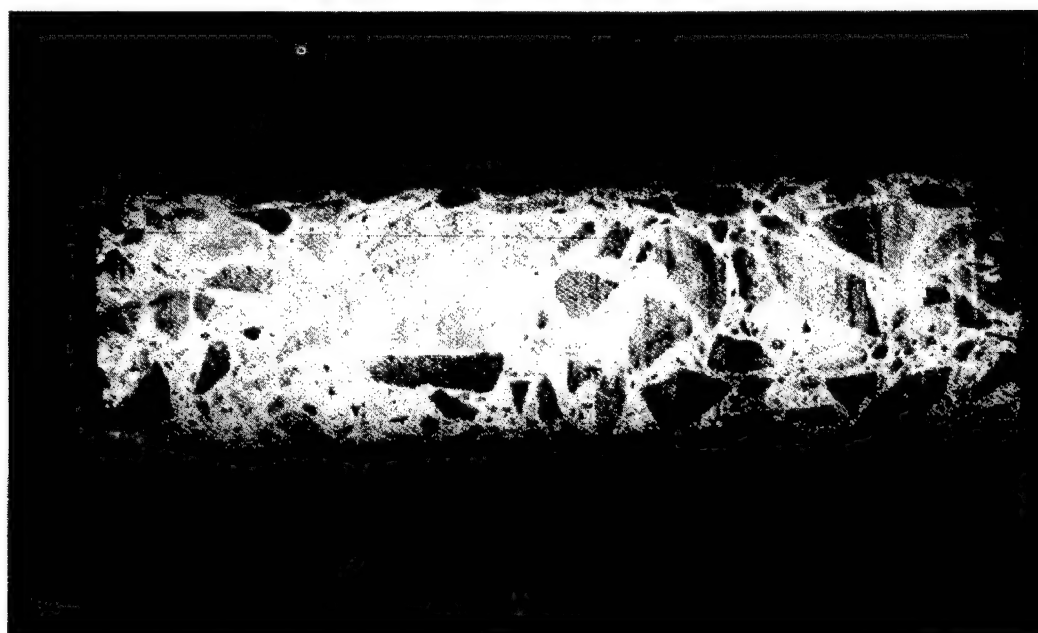
b. Concrete not refaced with shotcrete

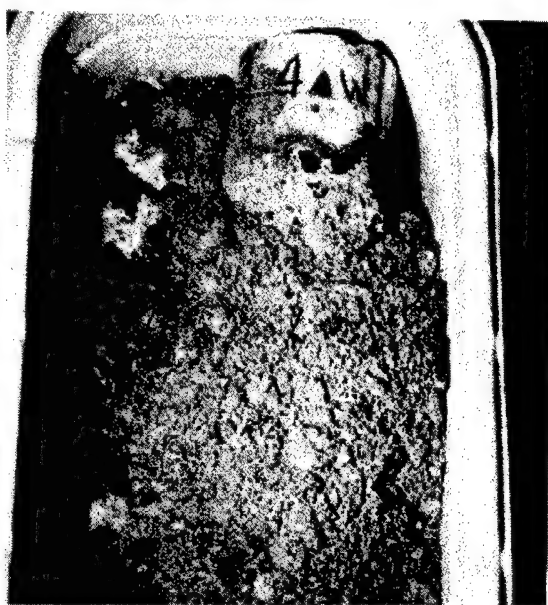
b. After freezing and thawing

Figure 8-8. Combination shotcrete and concrete core before and after 35 cycles of freezing and thawing in a saturated condition

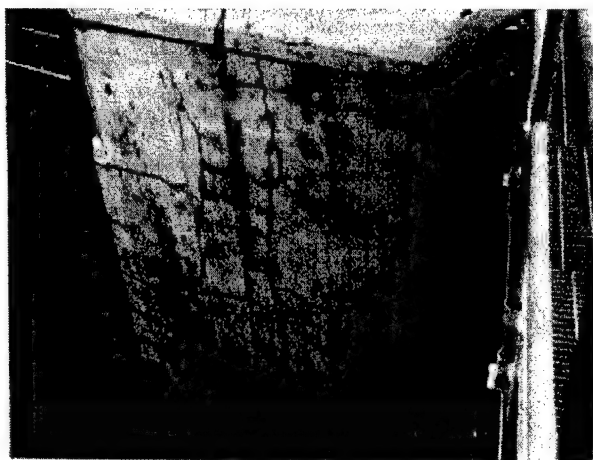
Figure 8-16. Typical cracking in miter gate monoliths resurfaced with cast-in-place concrete, Troy Lock, Hudson River (Miles 1993)

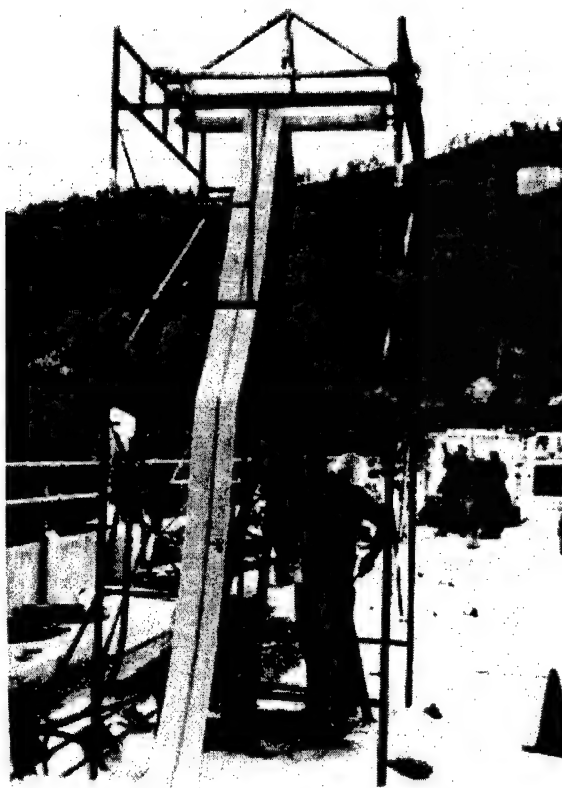
Figure 8-24. Inversion apparatus for installing tube in drill hole, Pine Flat Dam

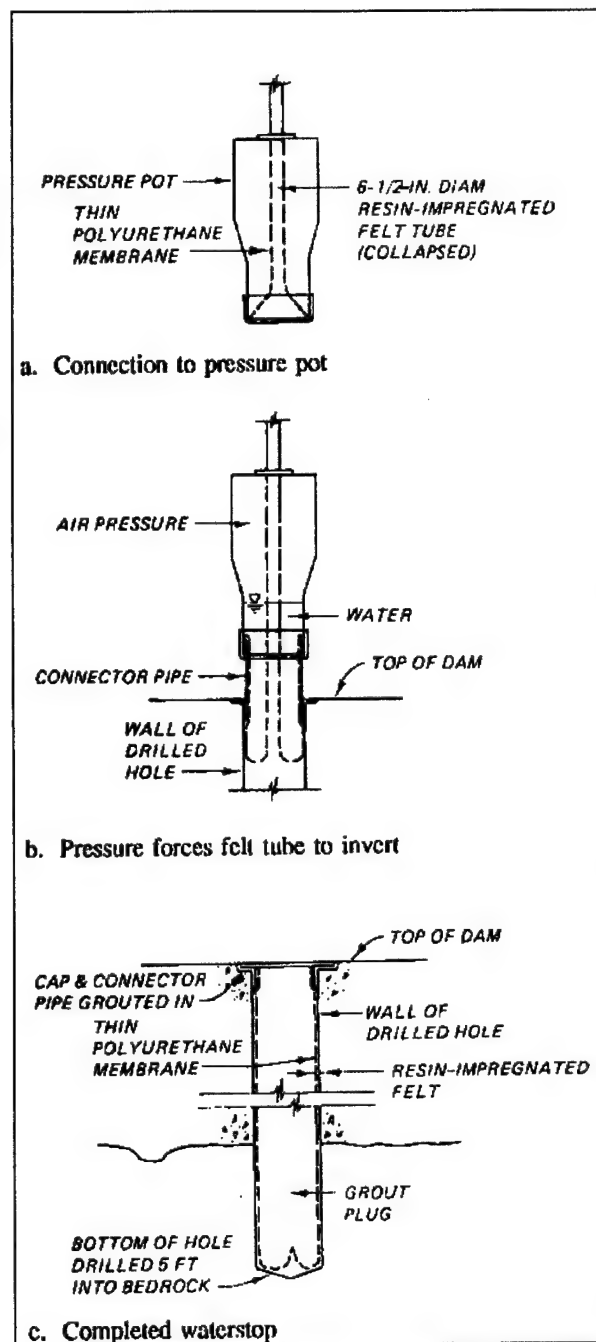
Figure 8-25. Remedial waterstop installation, Pine Flat Dam

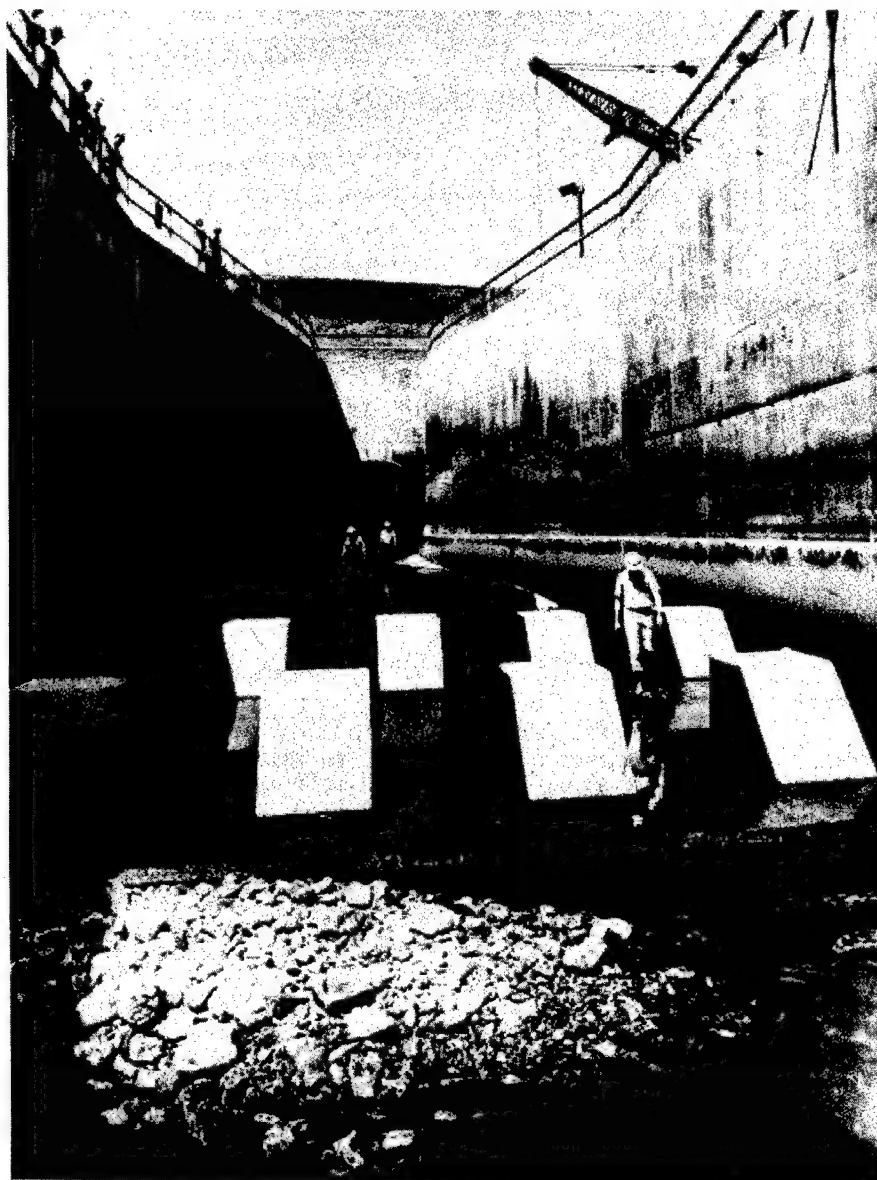
Figure 8-30. Stilling basin dewatered for inspection, Pomona Dam

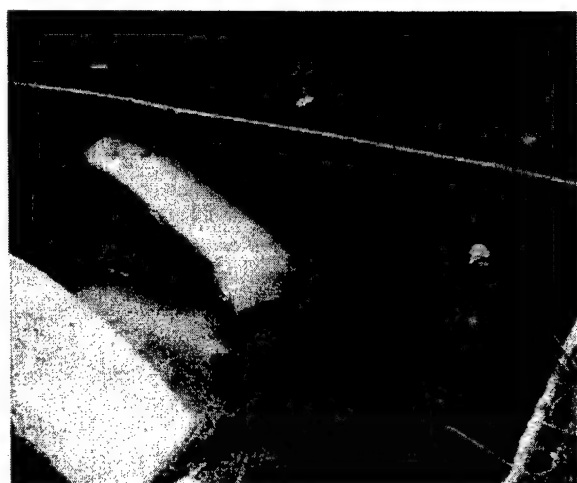
a. Scour holes behind baffles

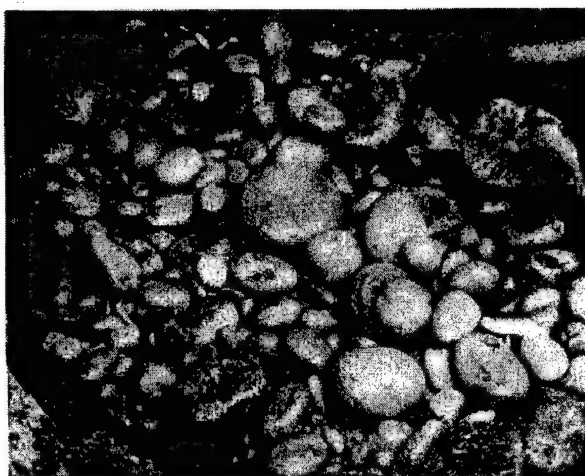
b. Debris in scour holes

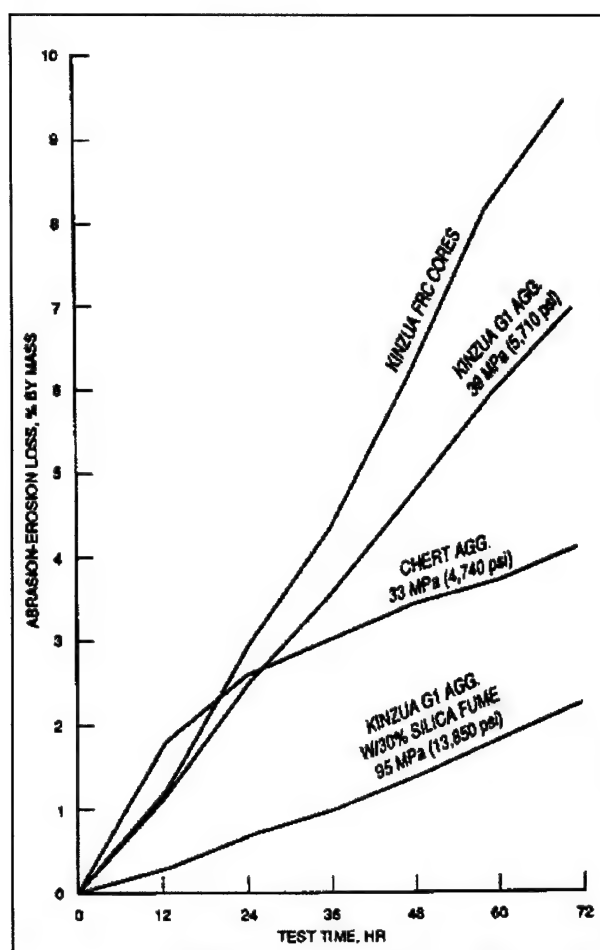
Figure 8-35. Results of selected abrasion-erosion tests, Kinzua Dam

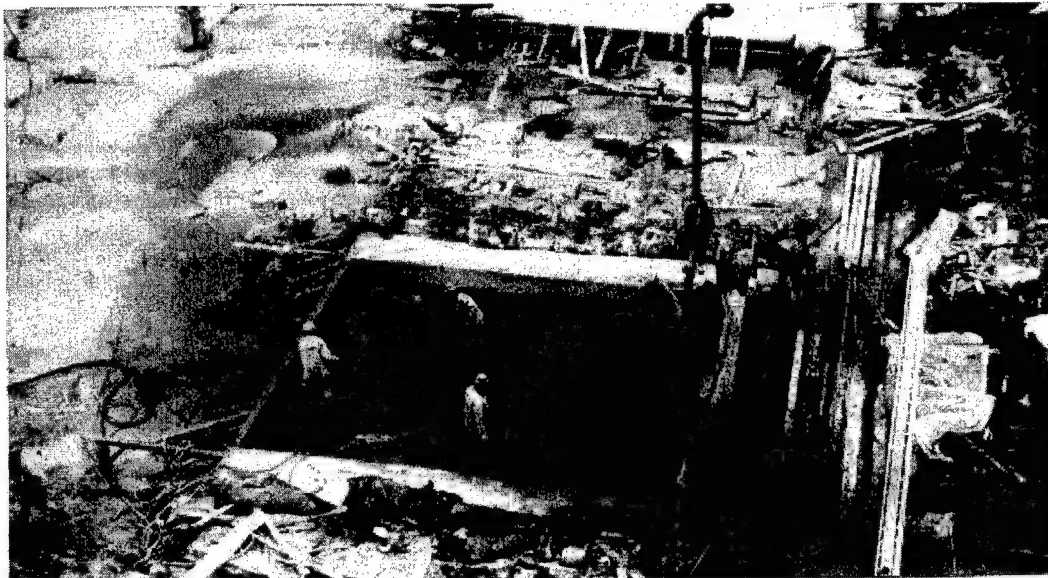
Figure 8-36. Pumping silica-fume concrete into the stilling basin from the top of the right training wall, Kinzua Dam

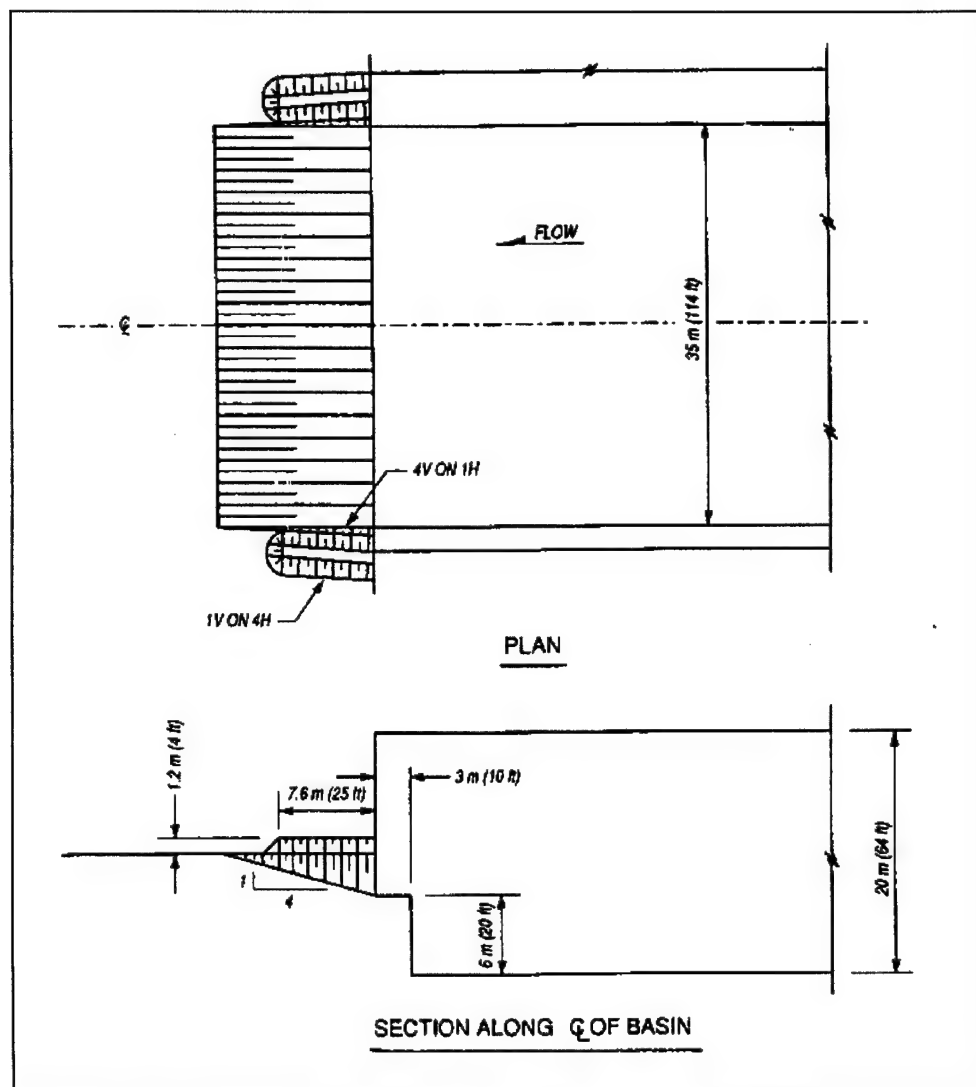
Figure 8-37. Stilling basin wall extension fills, Dworshak Dam
